Inspection Report

Minerals Regulatory Program

Mine Name: Expectation
Operator Name: Mark Miller

Permit number: M0350024
Inspection Date: May 5 and May 9, 2006
Time: 11:40 AM to 12:45 PM on May 5; 12:15-1:10 PM on May 9

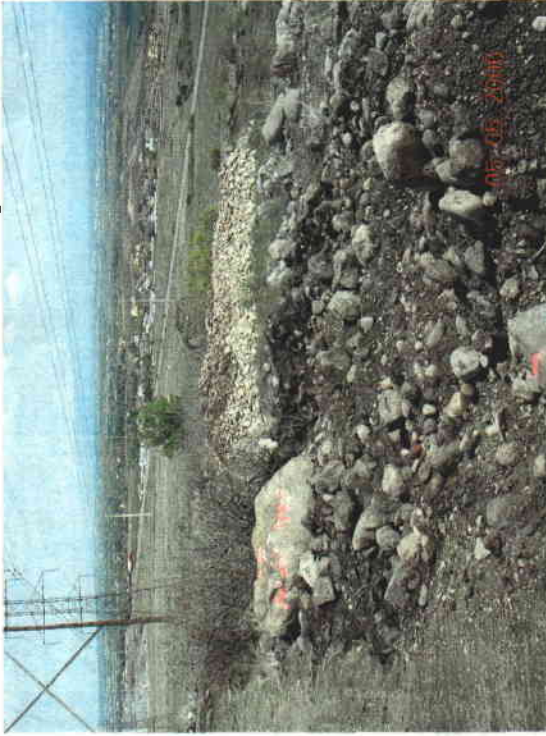
I collected GPS data around the perimeter of the disturbed areas, and the map created from this data is attached to this report. Some of the areas were obviously disturbed recently, such as those shown in Photos 1 through 3, 6, and 7. Other areas were disturbed last year and have not been redisturbed. In

Photo 1. Recent disturbance.

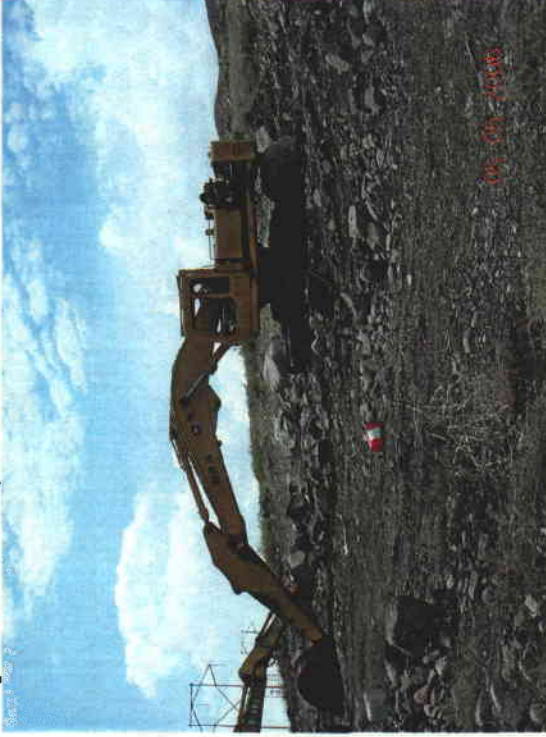
There are three trackhoes on site, one of which is not operational (Photo 3). The tracks and other parts have been removed from the trackhoe shown in Photo 3. There is a set of tracks lying on the surface in another part of the disturbed area (Photo 4).

Photo 3. The trackhoe in the center of the picture did not have tracks or some other vital parts, like a radiator. The one just barely visible on the left had been moved by the May 9 inspection.

The unoperational trackhoe and the tracks are reclamation liabilities to the Division. The operator needs to remove them from the site.

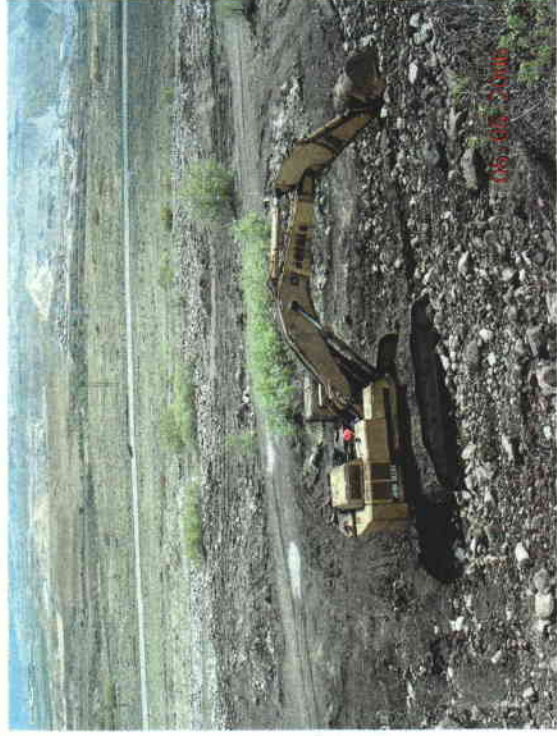
Most of the disturbance is in large blocks, such as shown in Photos 2 and 5, but there are several other places where individual small disturbances have been created along the edges of roads and in other areas (Photo 8).

Photo 2. The disturbance beyond the road is mostly in the permitted area, but the disturbance in the foreground is outside the permitted area.

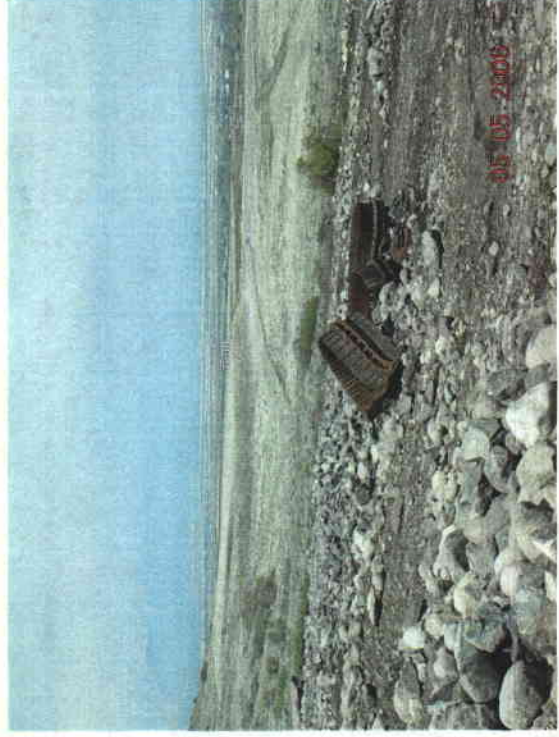
Photo 4. Tracks in an upper disturbed area.

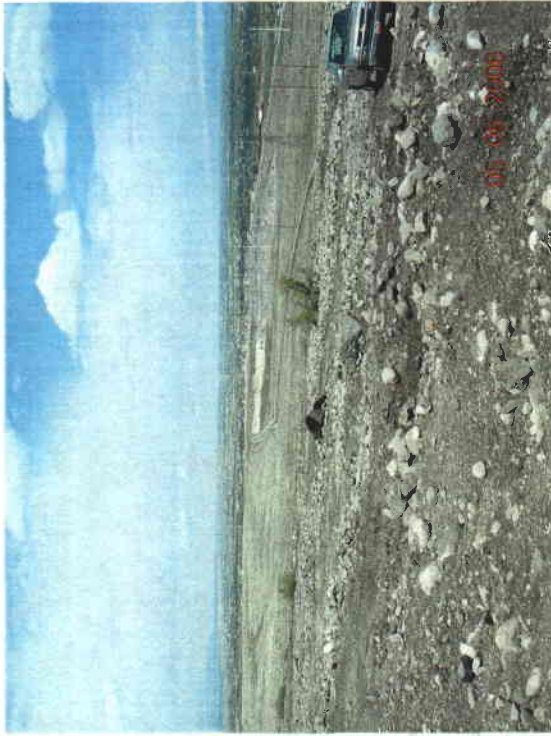
Photo 5. This is the western portion of the disturbed area. Much of this disturbance is permitted.

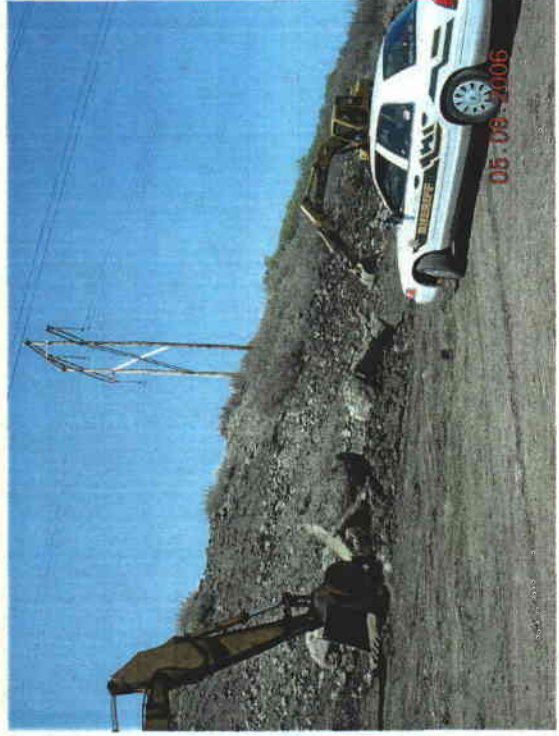
Photo 6. Another view of the disturbance shown in Photos 2 and 6.

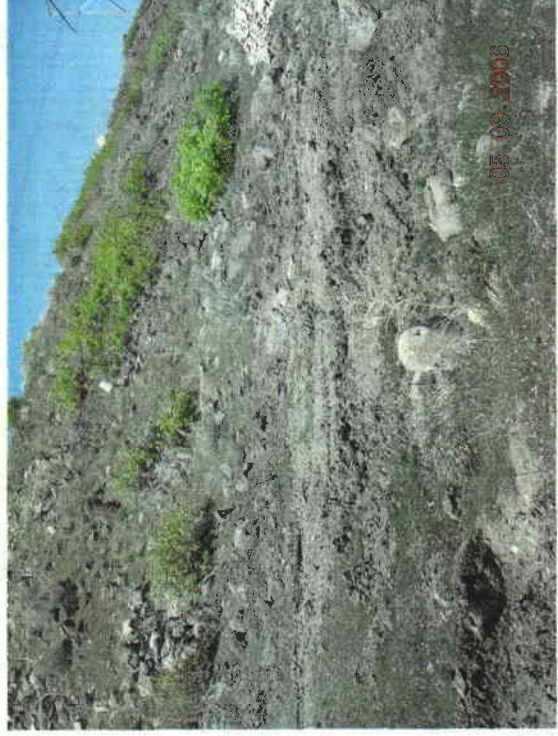
Photo 8. Some of the disturbance is small pockets from which it appears rocks have been removed.

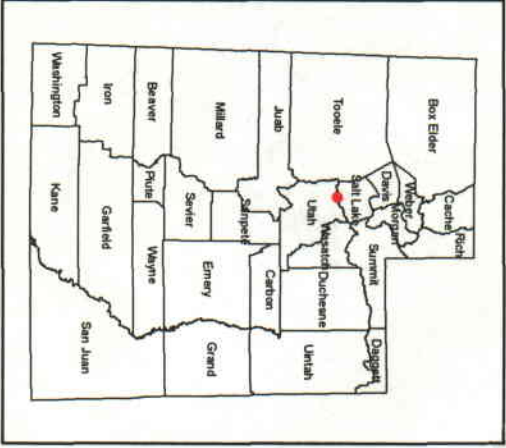
The total area disturbed by mining operations is at least 10.03 acres, and much of the disturbed area is outside the area included in the Notice of Intention to Commence Small Mining Operations. For this reason, I have issued cessation order MC2006-03-04-01. The area I mapped as being disturbed is the minimum disturbed area. There are places outside this area that were probably disturbed by the operator, and the actual disturbed area could be as much as about 13 acres.

The reclamation surety amount for this site is the minimum that would be required to reclaim the area shown in the notice; it is not adequate for reclamation of 10 acres or more and for removal of the equipment. For this reason, abatement of the cessation order includes submittal of additional surety. The operator is being given the option of reclaiming the area or submitting a Notice of Intention to Commence Large Mining Operations.
